Introduction

Sanitary pneumatic 3 way ball valves has been through the sophisticated inspection process and strict quality management. Using internal and external polishing and sterilization. Clamp quick connection, all-inclusive seal, easy to disassemble, cleaning and maintenance. Three-way sanitary ball valve for sanitary pipelines medium commutation, diversion, confluence, mixed flow. They can be manually operated or automated with an electric or pneumatic actuator.

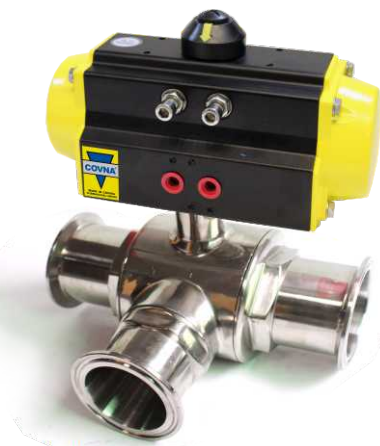
Double acting	Air to open, air to close, air supply failure to keep the current position
Single Acting N/C	Air to open, interrupt air to close, air failure to close
Single Acting N/O	Air to close, interrupt air to open, air failure to open
Optional accessory	Reversing solenoid valve, limit switch box, air filter reducing valve, positioner, handle manual, lock up valve

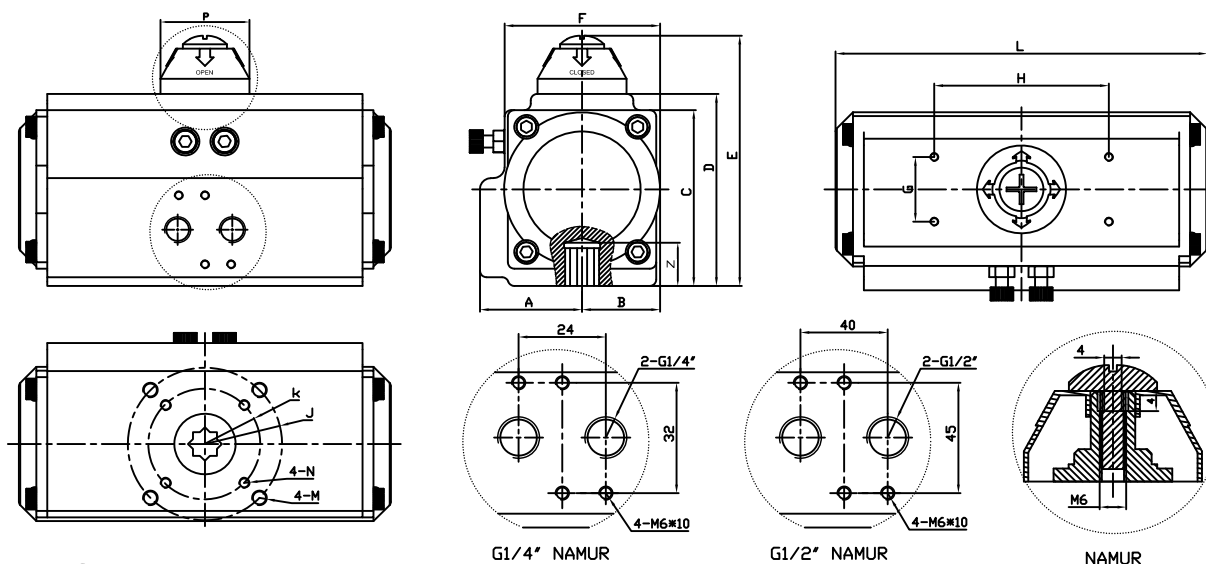
Outline Size drawing

MODEL	A	B	C	D	E	F	G	H	J	K	N	M	L	P	Z	Air Hole
AT52	30	42.5	65.5	72.4	92.5	50.5	30	80	∅36	∅50	M5×8	M6×10	150	42	14	NAMUR G1/4"
AT65	36	47	81	88.5	98.5	69.5	30	80	∅50	∅70	M6×10	M8×13	171	42	18	NAMUR G1/4"
AT75	42.5	53	93	100	120	78	30	80	∅50	∅70	M6×10	M8×13	186	42	18	NAMUR G1/4"
AT83	46.5	57	98.5	109.7	129.5	86	30	80	∅50	∅70	M6×10	M8×13	206	42	21	NAMUR G1/4"
AT92	50	58	106	117	137	90	30	80	∅50	∅70	M6×10	M8×13	265	42	21	NAMUR G1/4"
AT105	57.5	64	122.5	135	155	104.5	30	80	∅70	∅102	M8×13	M10×16	272	42	27	NAMUR G1/4"
At125	67.5	74.5	145.5	157	177	120.5	30	80	∅70	∅102	M8×13	M10×16	304	60	27	NAMUR G1/4"
AT140	75.5	75.5	161	174	194	125	30	80	∅102	∅125	M10×16	M12×20	395	60	32	NAMUR G1/4"
AT160	87	87	184	198	228	143	30	80	∅102	∅125	M10×16	M12×20	462	60	32	NAMUR G1/4"
AT190	103	103	216	232	262	172	30	130	∅102	∅140	M10×16	M16×25	520	85	40	NAMUR G1/4"
AT210	113	113	235.5	257	287	194	30	130	∅102	∅140	M10×16	M16×25	538	85	40	NAMUR G1/4"

AT240	130	130	235.5	292	322	230	30	130		∅165		M20×30	592	90	50	NAMUR G1/4"
AT270	147	147	235.5	331	361	253	30	130		∅165		M20×30	713	90	50	NAMUR G1/2"
AT300	161	168	235.5	354	384	290	30	130	∅165	∅215	M20×30	M20×30	771	90	50	NAMUR G1/2"
